DEPARTMENT OF TRANSPORTATION

Quality Assurance and Source Inspection

Contract #: 04-0120F4Cty: SF/ALA Rte: 80 PM: 13.2/13.9File #: 69.28**WELDING INSPECTION REPORT****Resident Engineer:**Siegenthaler, Peter**Address:** 333 Burma Road**City:** Oakland, CA 94607**Report No:** WIR-018374**Date Inspected:** 24-Nov-2010**Project Name:** SAS Superstructure**OSM Arrival Time:** 700**Prime Contractor:** American Bridge/Fluor Enterprises, a JV**OSM Departure Time:** 1900**Contractor:** Zhenhua Port Machinery Company, Ltd (ZPMC), Changxing Island **Location:** Shanghai, China**CWI Name:** Mr.Xu Le Fung.**CWI Present:** Yes No**Inspected CWI report:** Yes No N/A**Rod Oven in Use:** Yes No N/A**Electrode to specification:** Yes No N/A**Weld Procedures Followed:** Yes No N/A**Qualified Welders:** Yes No N/A**Verified Joint Fit-up:** Yes No N/A**Approved Drawings:** Yes No N/A**Approved WPS:** Yes No N/A**Delayed / Cancelled:** Yes No N/A**Bridge No:** 34-0006**Component:** Tower and Orthotropic Box Girder (OBG)**Summary of Items Observed:**

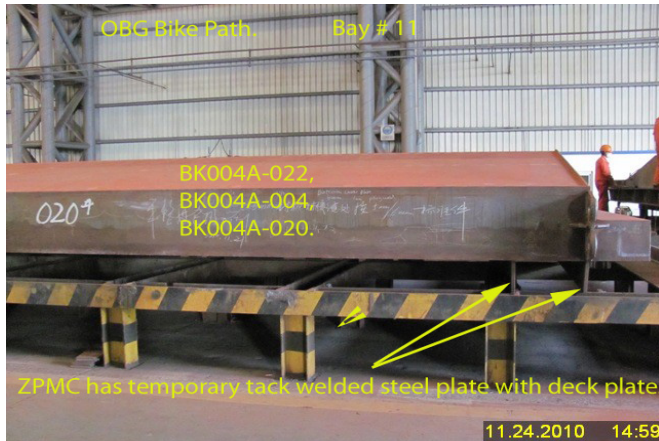
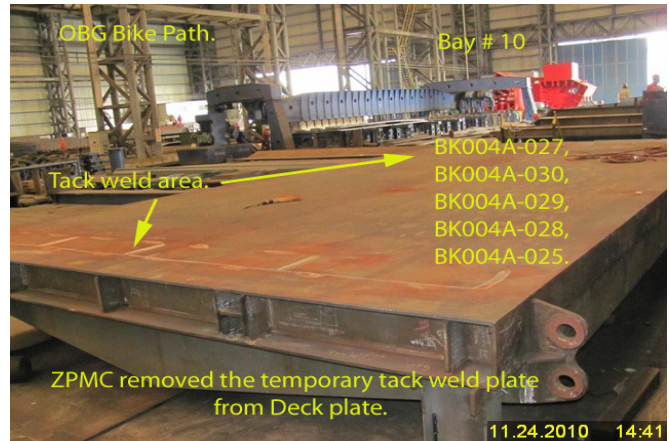
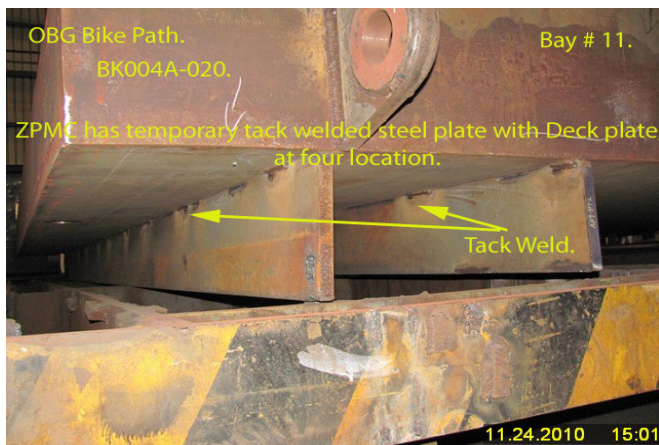
During the Quality Assurance (QA) random visual inspection of OBG Bike path, in Bay 10 # and Bay # 11. this Quality Assurance Inspector (QA) discovered the following issues: ZPMC has temporary tack welded steel plates on top of the Deck plate. The following Bike paths are identified.

-There are total of four (4) steel plates welded with deck plate of each Bike Path. The approved shop drawings do not specify any welds in these locations. The Top plates are identified as: BKPL1 and BKPL2. The additional material and welding was not approved by the engineer. The steel plate material is unknown. OBG Bike path is located in inside BAY 10 and BAY 11. For further information, please see the attached pictures. Incident report to be generated on this date.
